October 23, 2006

Hydraulic Grade Line Analysis of Tollgate storm sewer system and Opinion on unit flooding

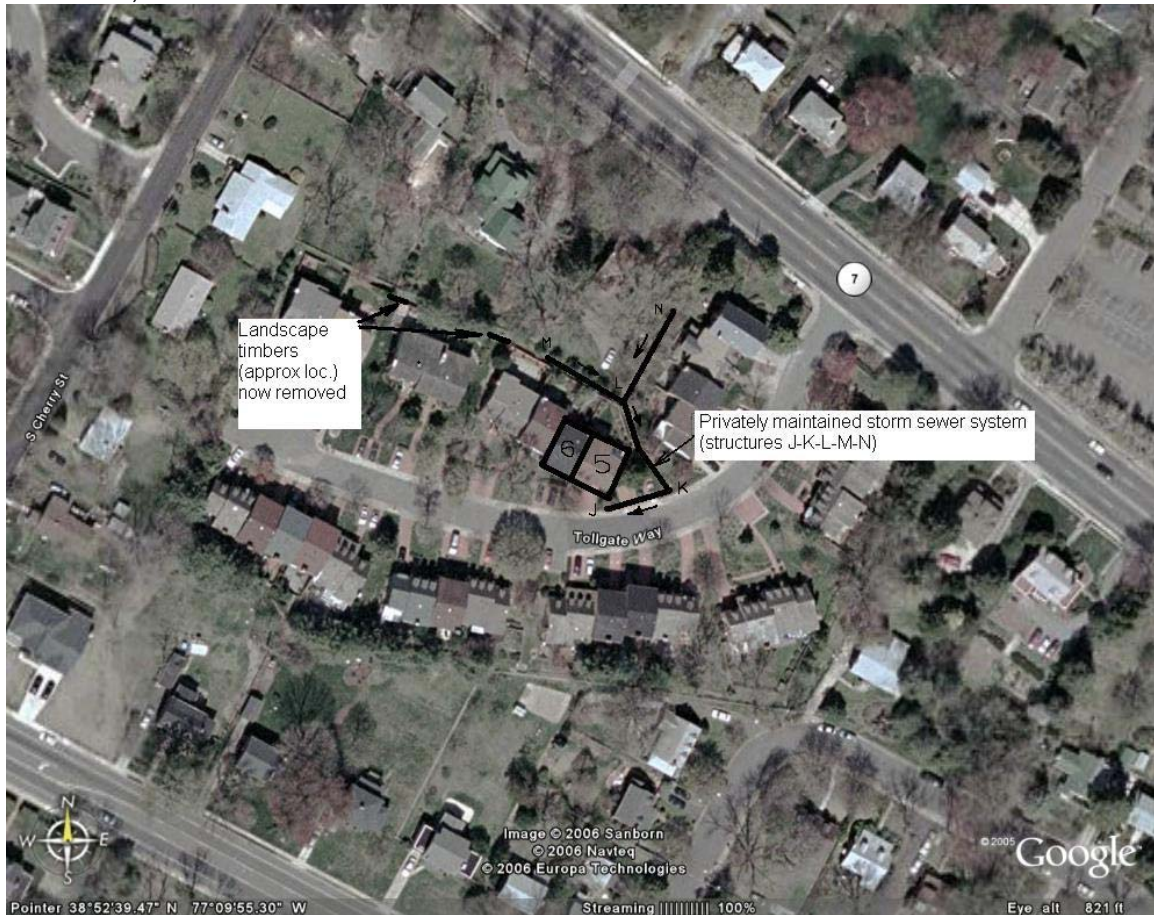
The community is located on the south side of Virginia Route 7 in the City of Falls Church situated along both sides of Tollgate Way. An aerial photograph² of the site area, subject storm sewer system and Lots 5 & 6 of the subdivision are shown, for reference, in the exhibit below.

The storm sewer system shown above is the upper portion of a system which drains Tollgate and adjacent properties and is owned, as we understand it, by the Tollgate HOA. The system drains into a publicly maintained system below structure point "J" (this portion of the system not shown on the exhibit). The system layout, pipe sizes, grades and elevations are shown on the site plan for Tollgate³.

The approximate reported location of two landscape timber diversions reportedly installed by the HOA are shown on the exhibit and are discussed later in this report.
